INDOOR AIR QUALITY ASSESSMENT

**Francis J. Muraco Elementary School
33 Bates Road
Winchester, Massachusetts**

Prepared by:
Massachusetts Department of Public Health
Bureau of Environmental Health Assessment
January, 2002

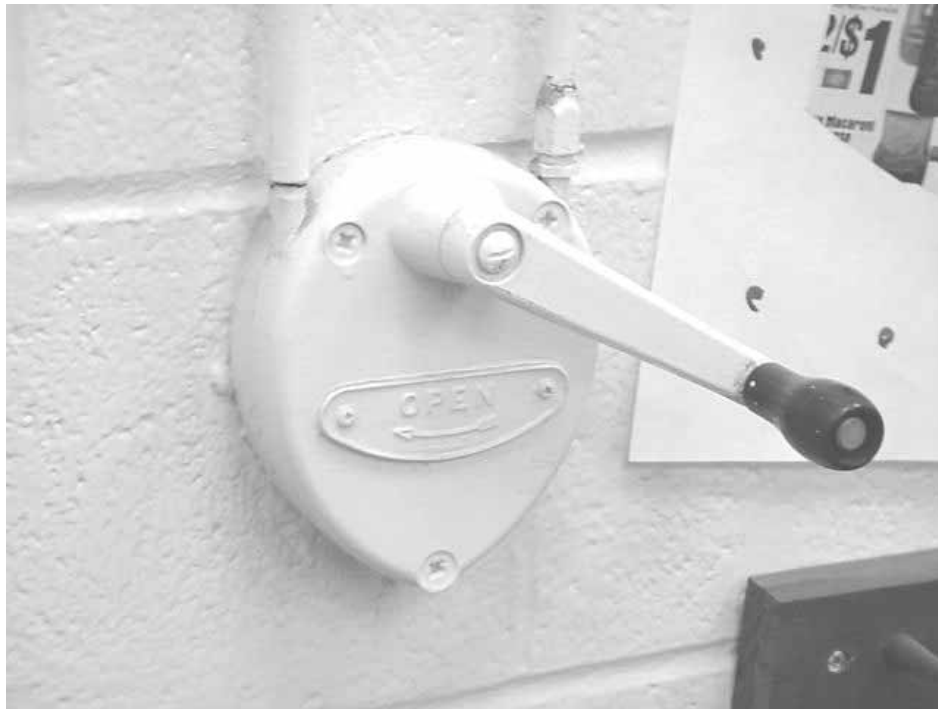
Picture 1

The school is a one-story brick-on-cement-slab building constructed in the mid 1960's. The school contains general classrooms, a music room, library, gymnasium, kitchen/cafeteria, several reading/resource rooms and offices. Classrooms are not fully enclosed but are separated into pods by five-foot high dividers. Windows throughout the building are openable, however school staff reported that they are difficult to open in a number of areas (e.g. damaged equipment, missing cranks) (see Picture 1).

**Wall-Mounted Window Control Mechanism, A Number of Which Were
Non-Functional or Difficult to Operate**

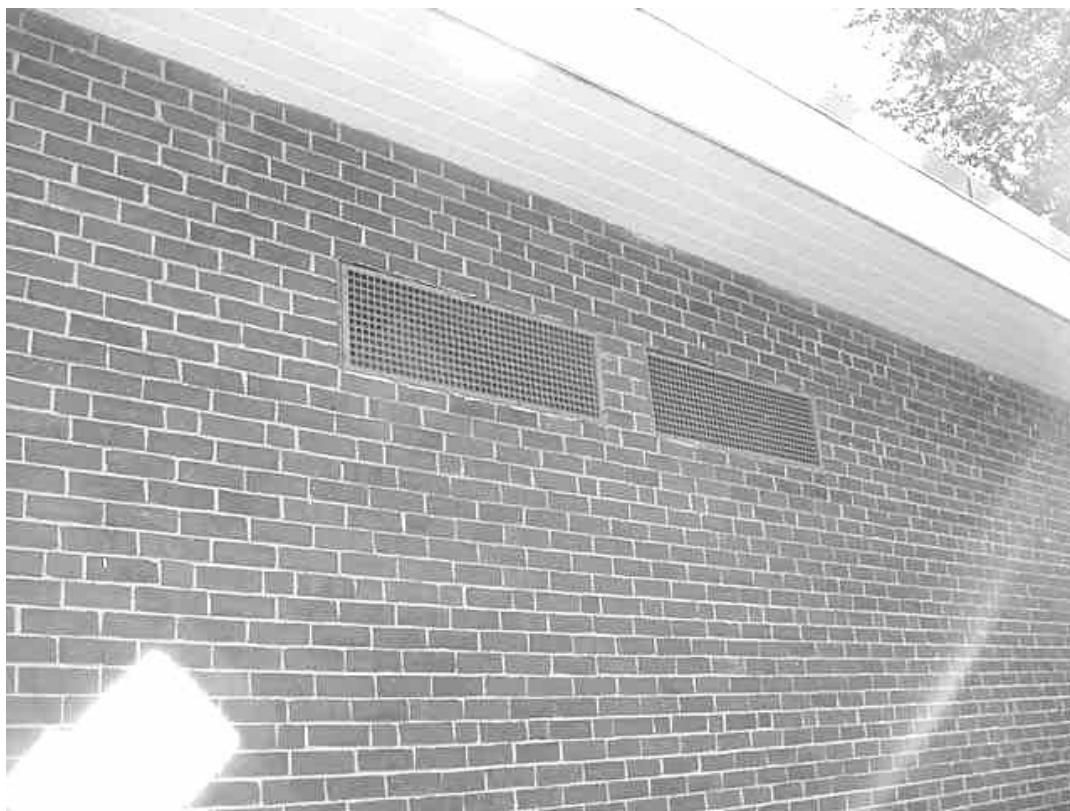
Picture 2

Fresh air in classrooms is supplied by a unit ventilator (univent) system. Univents draw air from outdoors through a fresh air intake located on the exterior walls of the

building (see Picture 2) and return air through an air intake located at the base of each unit (see [Figure 1](#)). Fresh air and return air are mixed, filtered, heated and provided to classrooms through a fresh air diffuser located in the top of the unit. It was reported that univents are normally not activated until the start of the heating season. BEHA staff explained that these units not only provide heat but are designed to provide a constant source of ventilation. After discussion, school maintenance staff reactivated univents. Univents were operable in all areas after activation, however the unit in the teacher's lounge repeatedly deactivated, indicating a mechanical malfunction. Also of note was the univent in classroom K-2. Although the unit was operating on the "high" setting it was producing very little airflow. Lack of airflow can indicate a mechanical problem with the univent. To function as designed, these units must be activated and allowed to operate during hours of school occupancy.

Univent Fresh Air Intakes

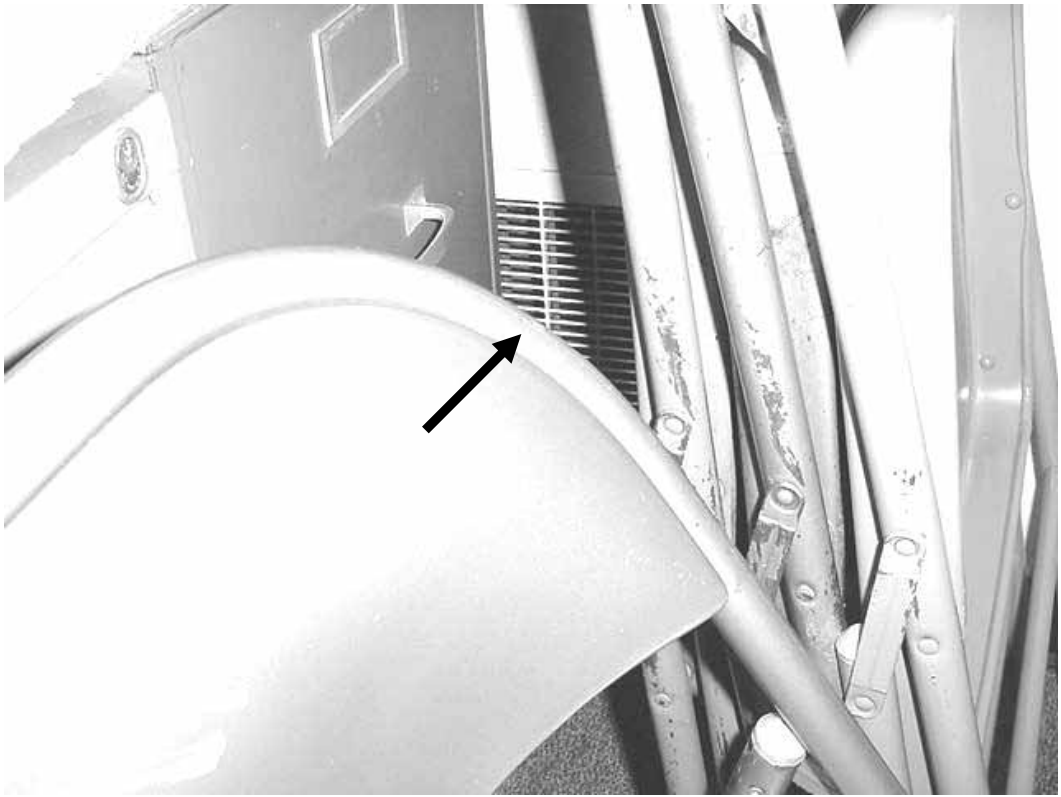
Picture 3

The mechanical exhaust ventilation system consists of wall-mounted exhaust vents. No draw was detected in classrooms K-1 & K-2, which can indicate that either the exhaust ventilation was turned off, or that rooftop motors were not functioning. A number of exhaust vents were obstructed by tables, chairs, boxes and other items (see Picture 3). The location of some exhaust vents can also limit exhaust efficiency when the classroom hallway door is open (see Picture 4). When a classroom door is open, exhaust vents will tend to draw air from both the hallway and the classroom. The open hallway door reduces the effectiveness of the exhaust vent to remove common environmental pollutants from classrooms. Without removal by the exhaust ventilation, normally occurring environmental pollutants can build up and lead to indoor air complaints.

Obstructed Classroom Exhaust Vent

5. Remove all obstructions from univents and mechanical exhaust vents to facilitate airflow.
6. For buildings in New England, periods of low relative humidity during the winter are often unavoidable. Therefore, scrupulous cleaning practices should be adopted to minimize common indoor air contaminants whose irritant effects can be enhanced when the relative humidity is low. To control for dusts, a HEPA filter equipped vacuum cleaner in conjunction with wet wiping of all surfaces is recommended. Drinking water during the day can help ease some symptoms associated with a dry environment (throat and sinus irritations).

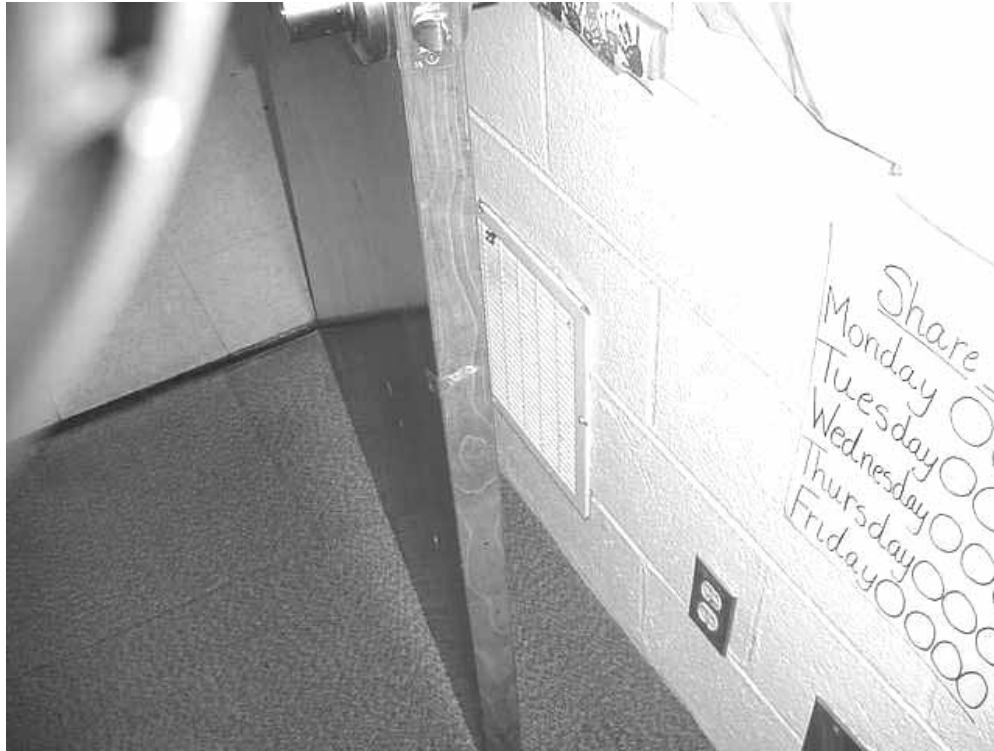
Picture 4

Classroom Exhaust Vent behind Open Door

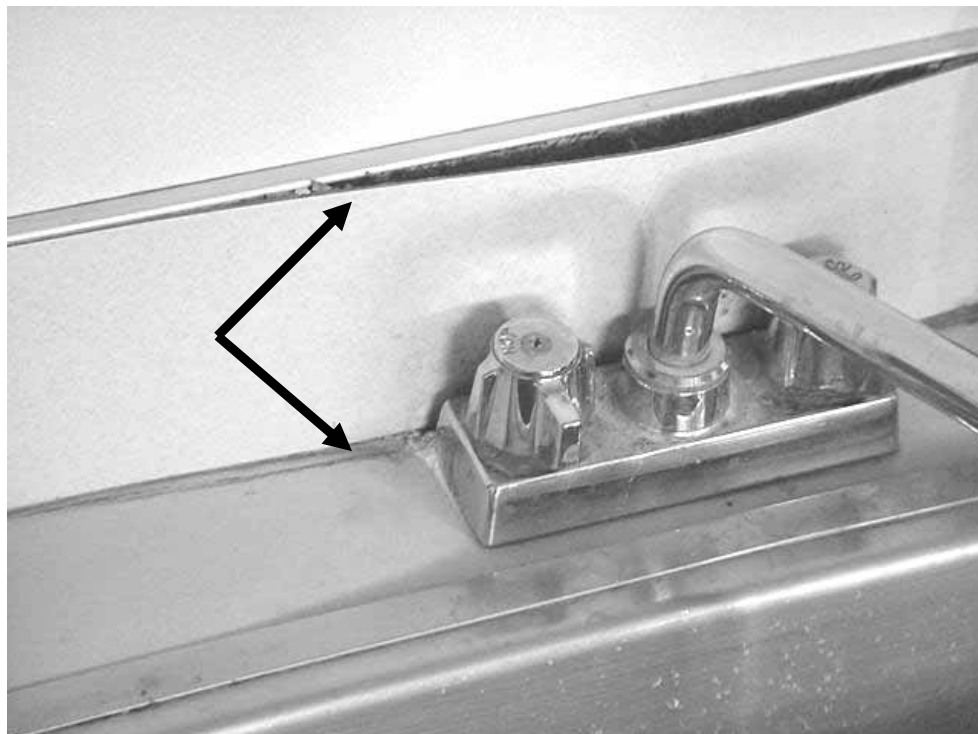
Picture 5

Spaces between the sink countertop and backsplash were noted in a number of classrooms (see Picture 5). A leaking faucet was noted in classroom 9. Repeated leakage or improper drainage/overflow of water in sinks can lead to water penetration/damage of countertop wood, the cabinet interior, areas behind cabinets and carpeting. Like other porous materials, if these materials become wet repeatedly they can provide a medium for mold growth.

Spaces around Classroom Sink and Backsplash

7. Repair leaky faucet in classroom 9.
8. Seal areas around sinks to prevent water-damage to the interior of cabinets and adjacent wallboard. Inspect wallboard behind cabinets for water-damage and mold growth, repair/replace as necessary. Disinfect areas of microbial growth with an appropriate antimicrobial as needed.

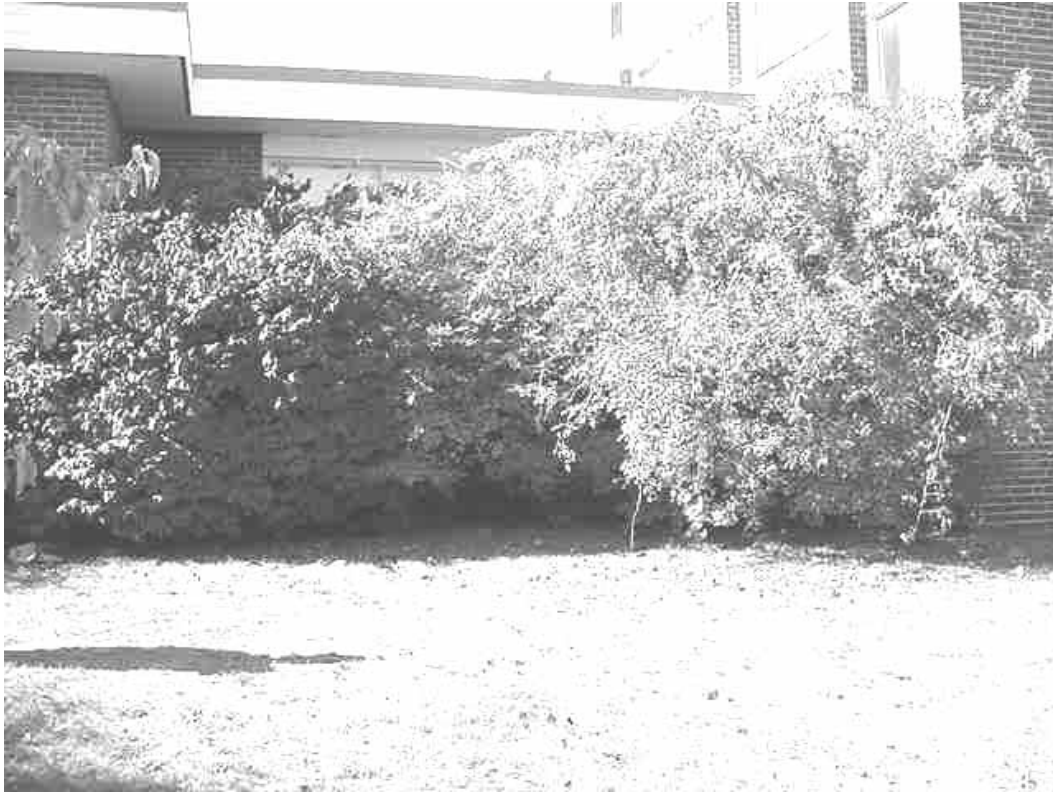
Picture 6

Along the perimeter of the building, shrubbery and flowering plants were noted in close proximity to univent fresh air intakes (see Picture 6). Shrubbery and flowering plants can be sources of mold and pollen and should be placed and/or maintained to ensure that fresh air intakes remain clear of obstructions to prevent the entrainment of dirt, pollen or mold into the building. In addition, plants can hold water against the exterior of the building. Over time freezing/thawing action during the winter can weaken bricks and mortar, resulting in damage to the building envelope.

Shrubbery Obstructing Univent Air Intake

9. Inspect plant growth outside perimeter of building periodically; trim plant growth away from fresh air intakes as needed.

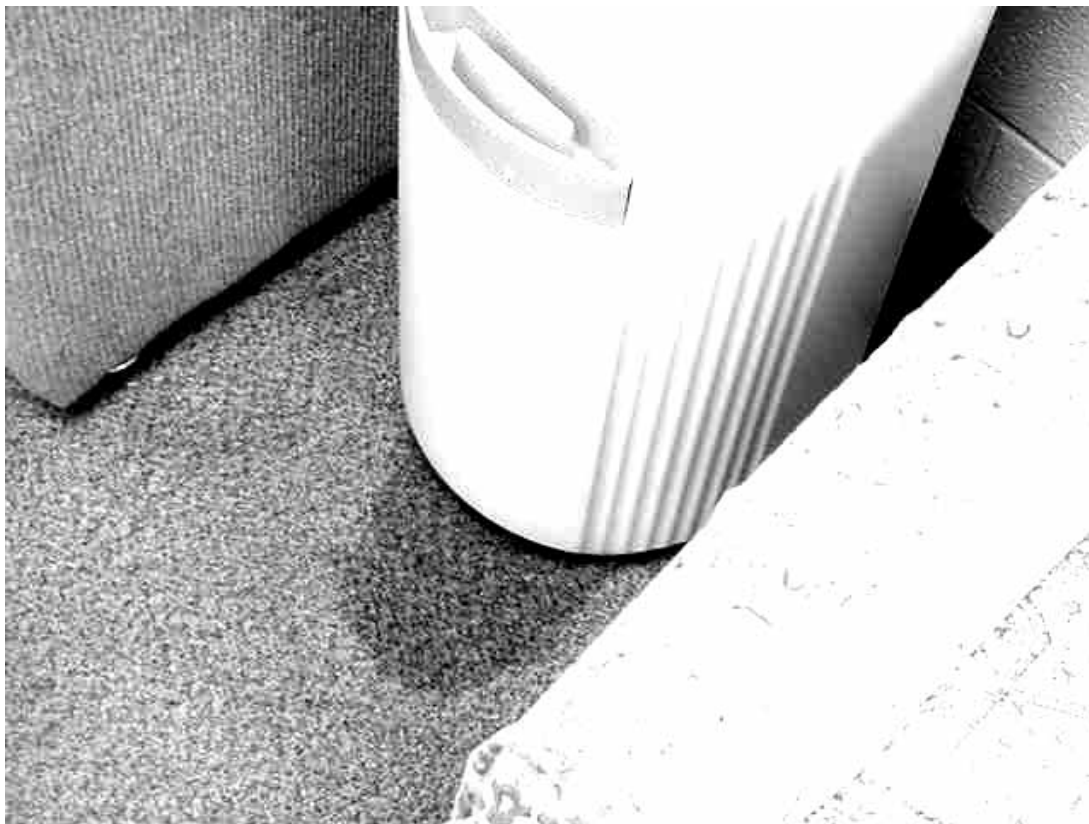
Picture 7

The faculty lounge and nurse's office contained a water cooler and a sink mounted over carpeted floors. Water stains were noted around the water cooler in the faculty lounge (see Picture 7). The American Conference of Governmental Industrial Hygienists (ACGIH) recommends that carpeting be dried with fans and heating within 24 hours of becoming wet (ACGIH, 1989). If carpets are not dried within this time frame, mold growth may occur. Once mold has colonized porous materials, they are difficult to clean and should be removed.

Water Stained Carpet under Water Cooler
